OPERATION OF MALE UAV IN THE GERMAN AIRFORCE

+ Mishap Investigation under Combat Environment
and Corona

2. System description Heron 1

6. Mishap Investigation

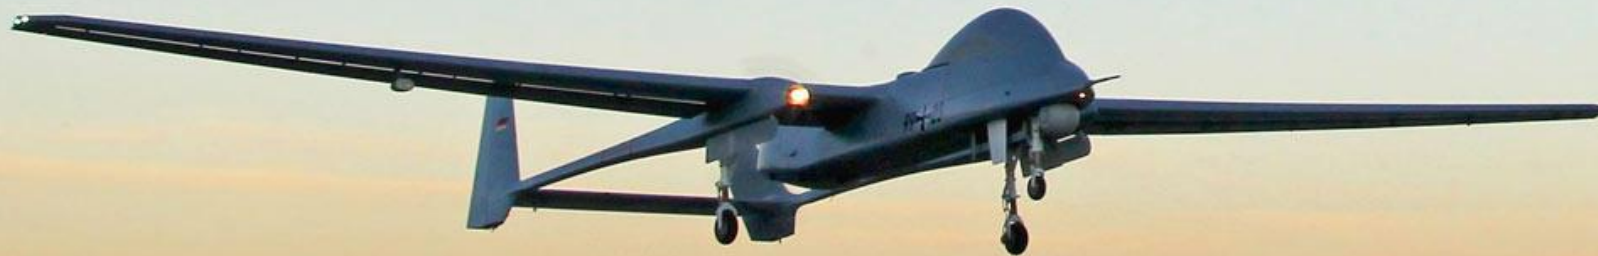
Performance data

MTOW: 1150 kg
Payload: max. 250 kg

Powerplant: Rotax 914
115 PS / 5500 rpm
1211,3 ccm

Duration : operational 16 - 27 h
Altitude : max 30.000 ft
Speed : 60 – 115 KTS
Cruise : 70 – 80 KTS
Loiter : 65 KTS

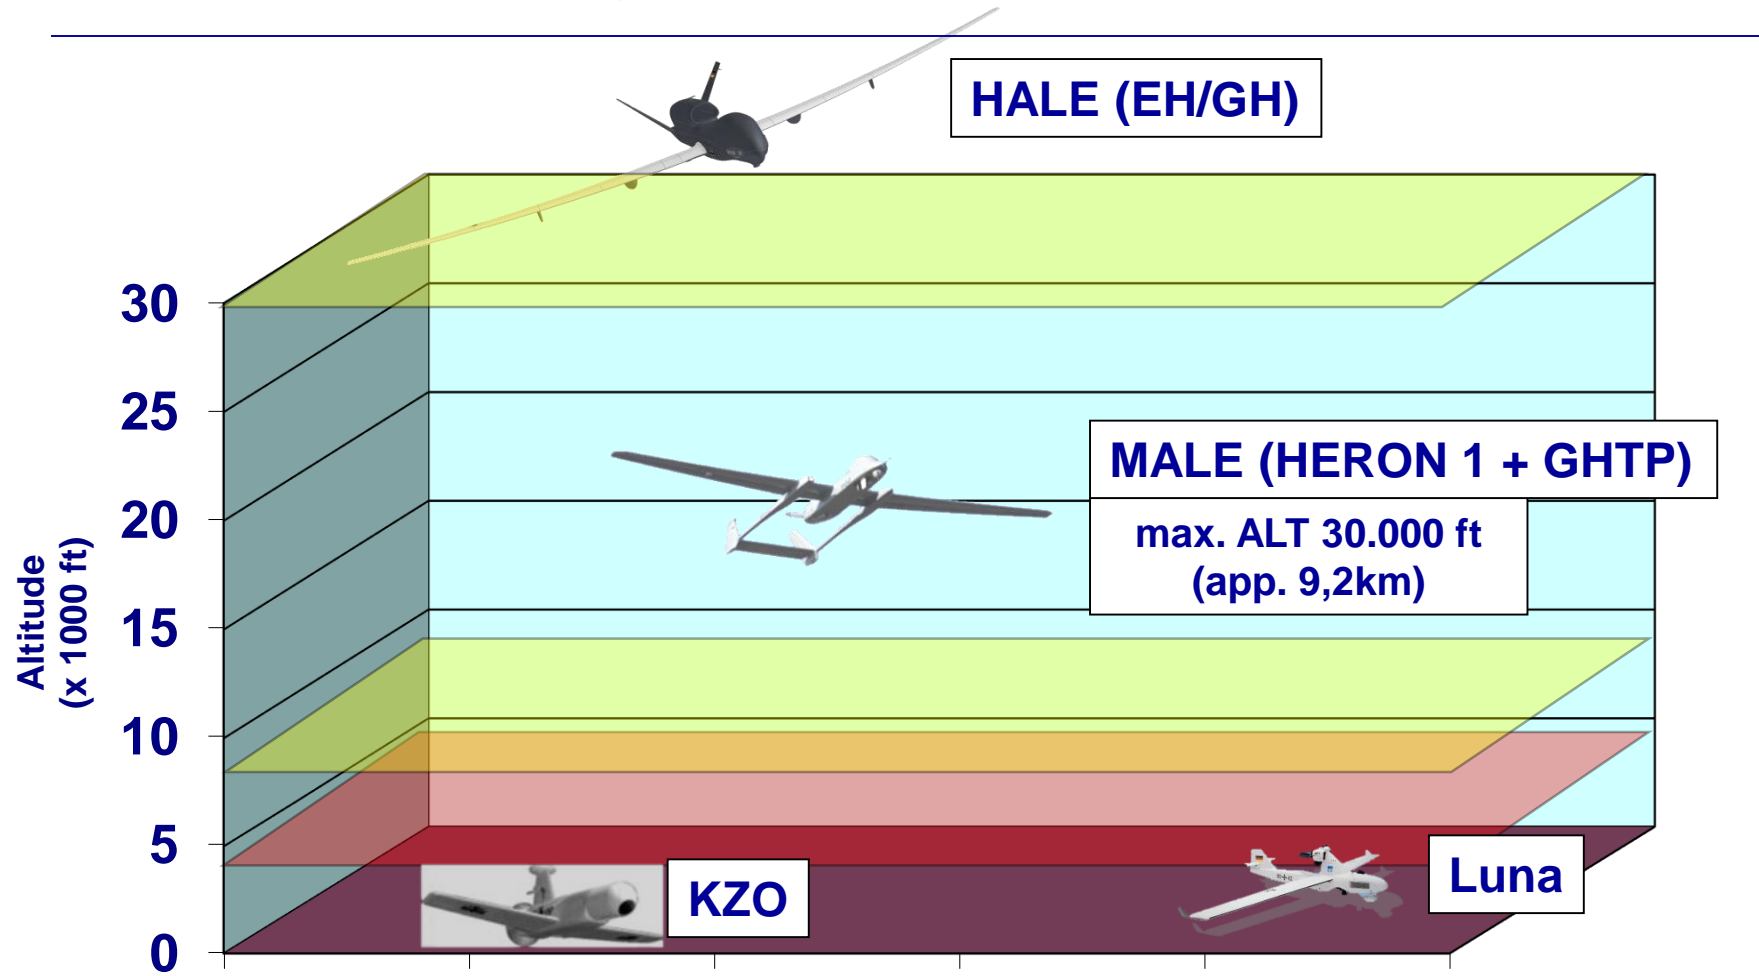
UAS Classes

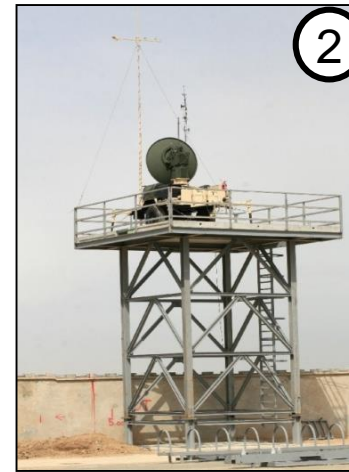
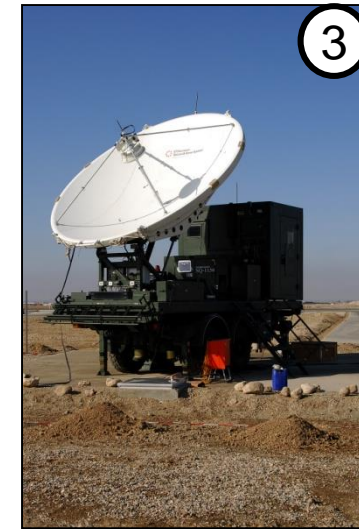
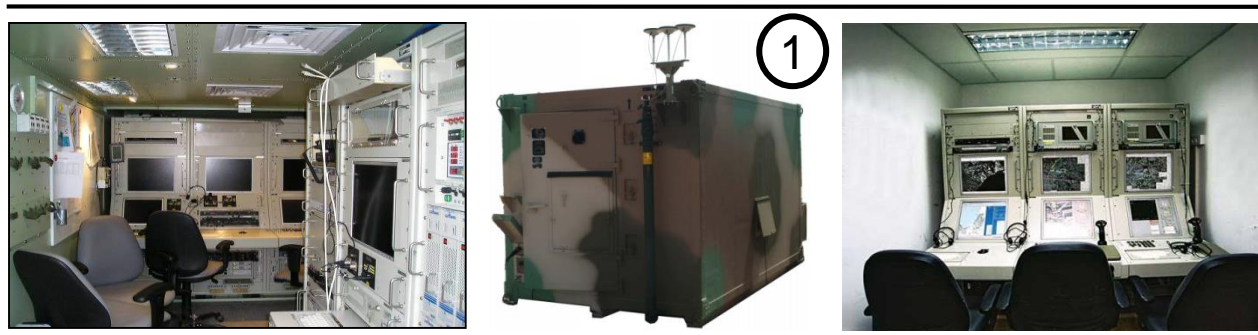
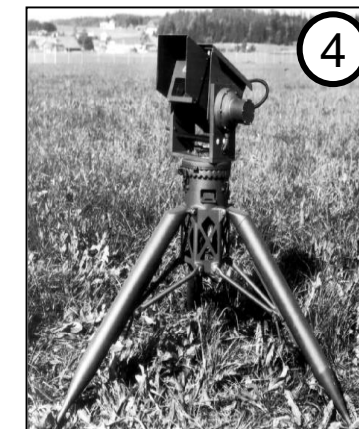
Ground components

1. Advanced Ground Control Station
AGCS
2. Ground Data Terminal
GDT
3. Ground Satellite Terminal
GST
4. Range Auto Positioning System
RAPS

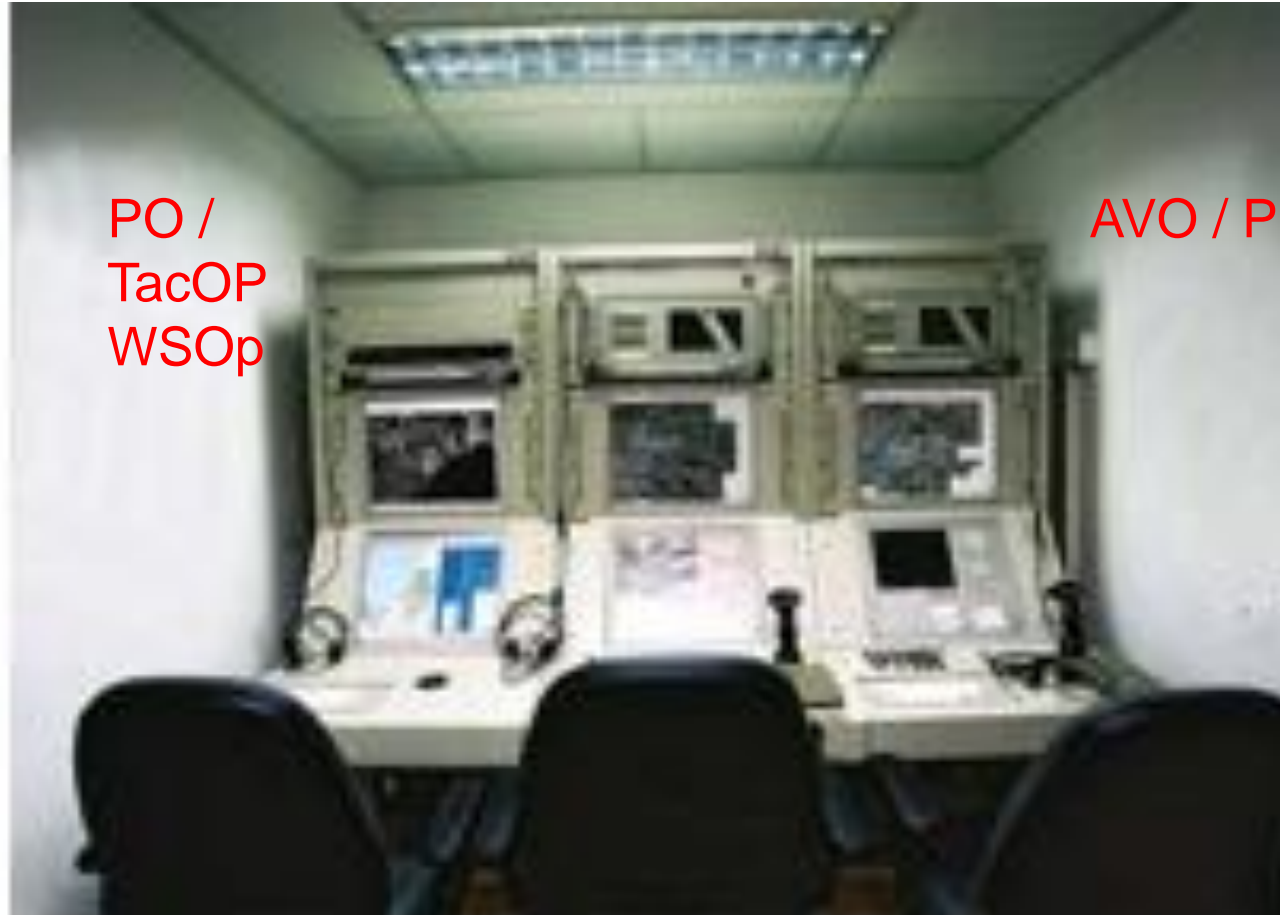
AGCS

Cockpit

PO /
TacOP
WSOp

AVO / PILOT

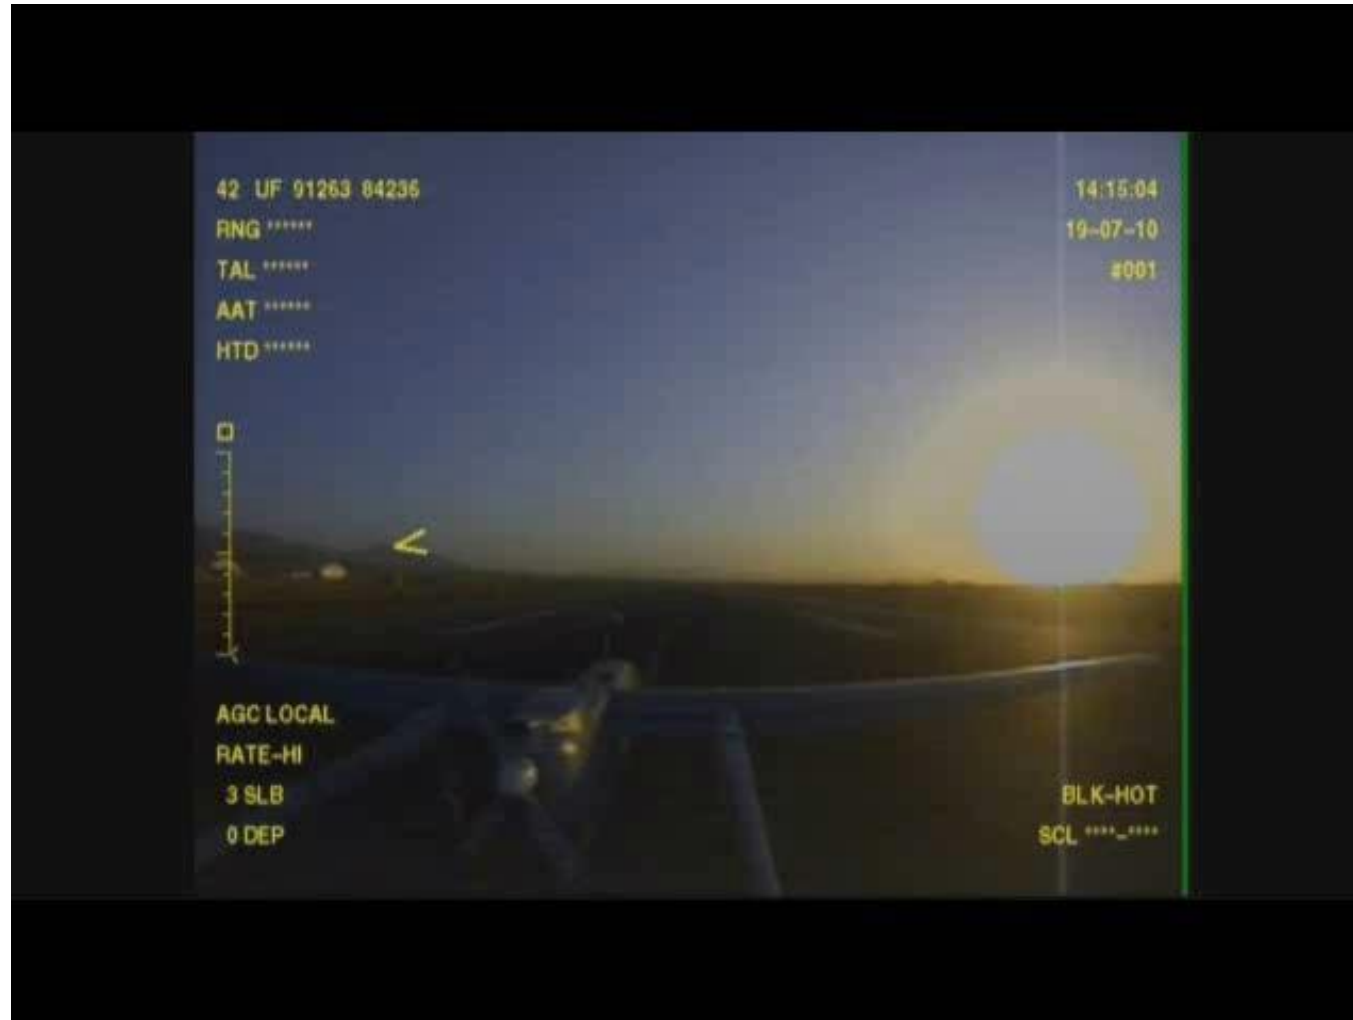
PANO image incl. MOSP annotations

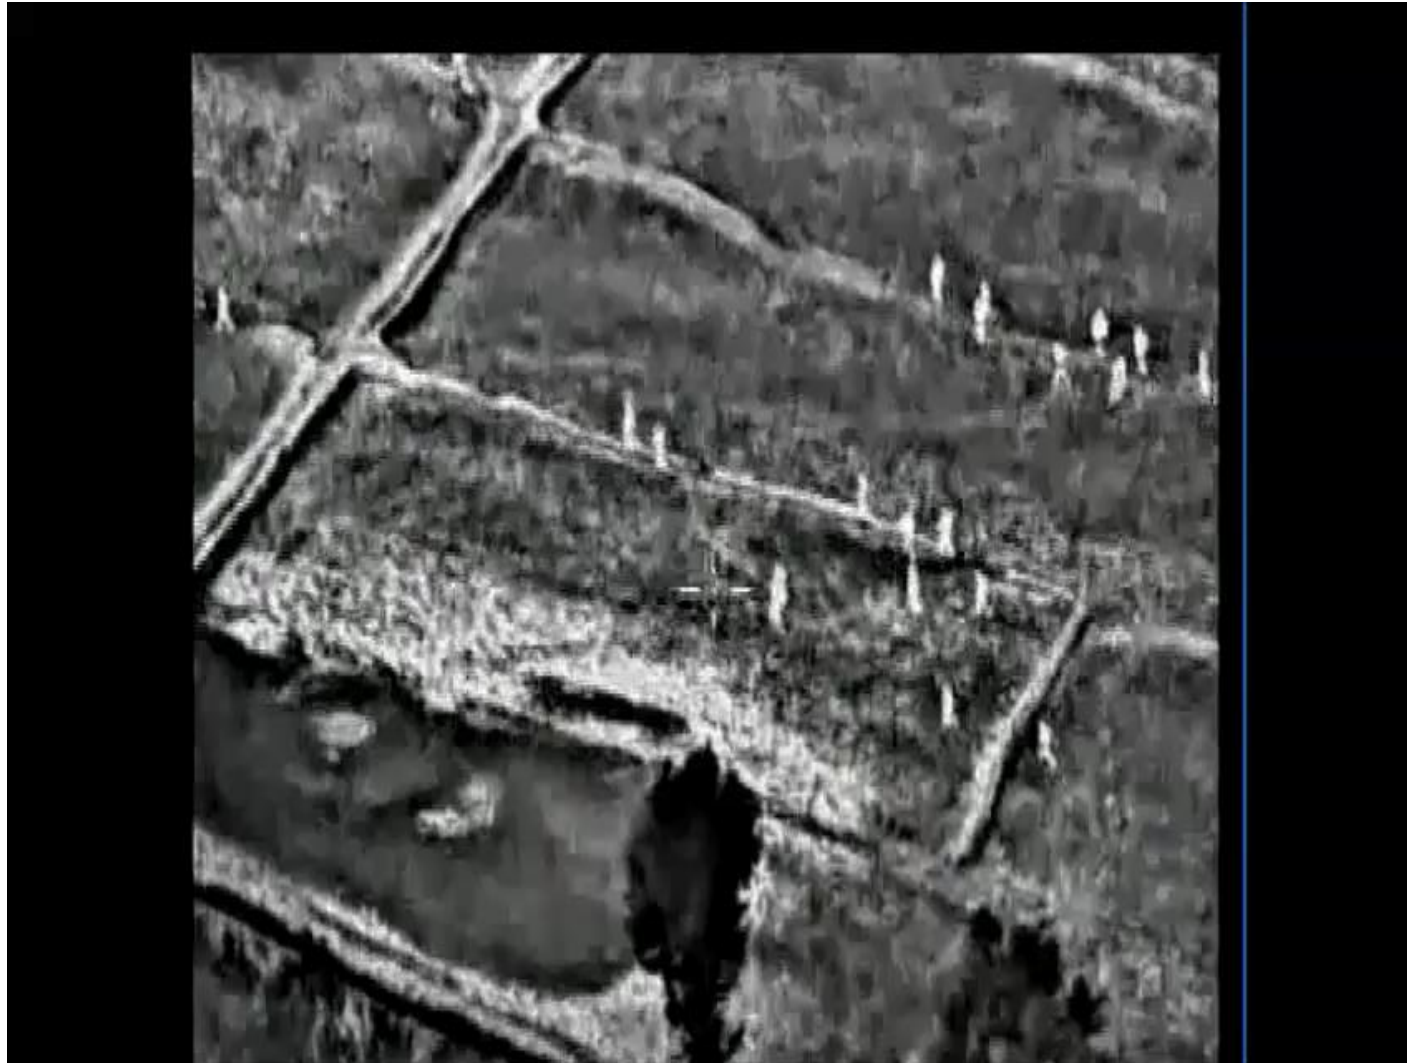
3. Sensors IR

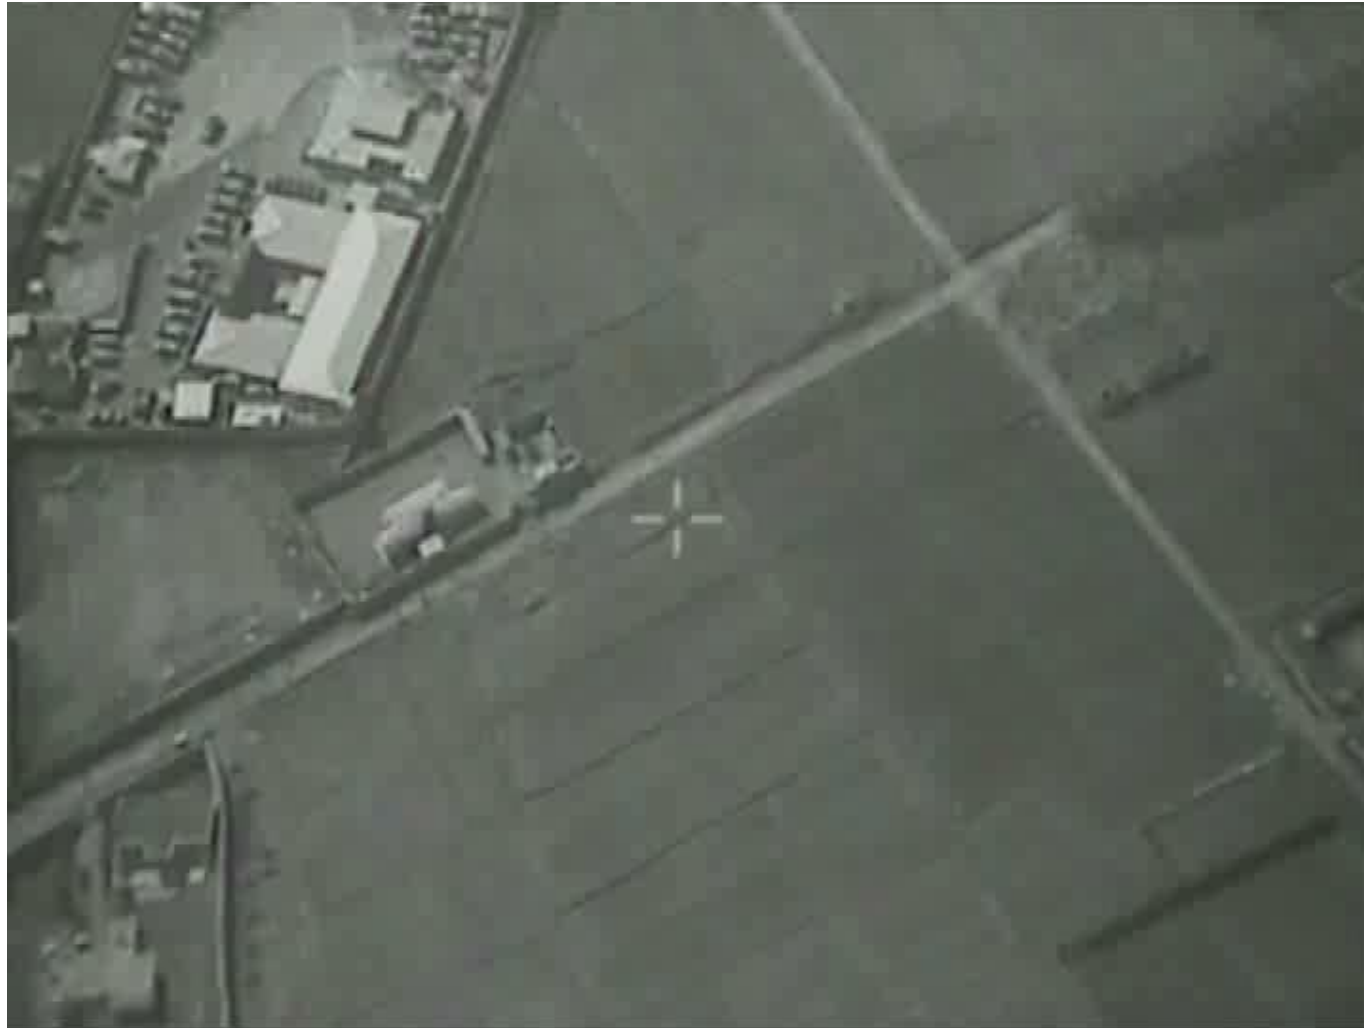
3. Sensors EO

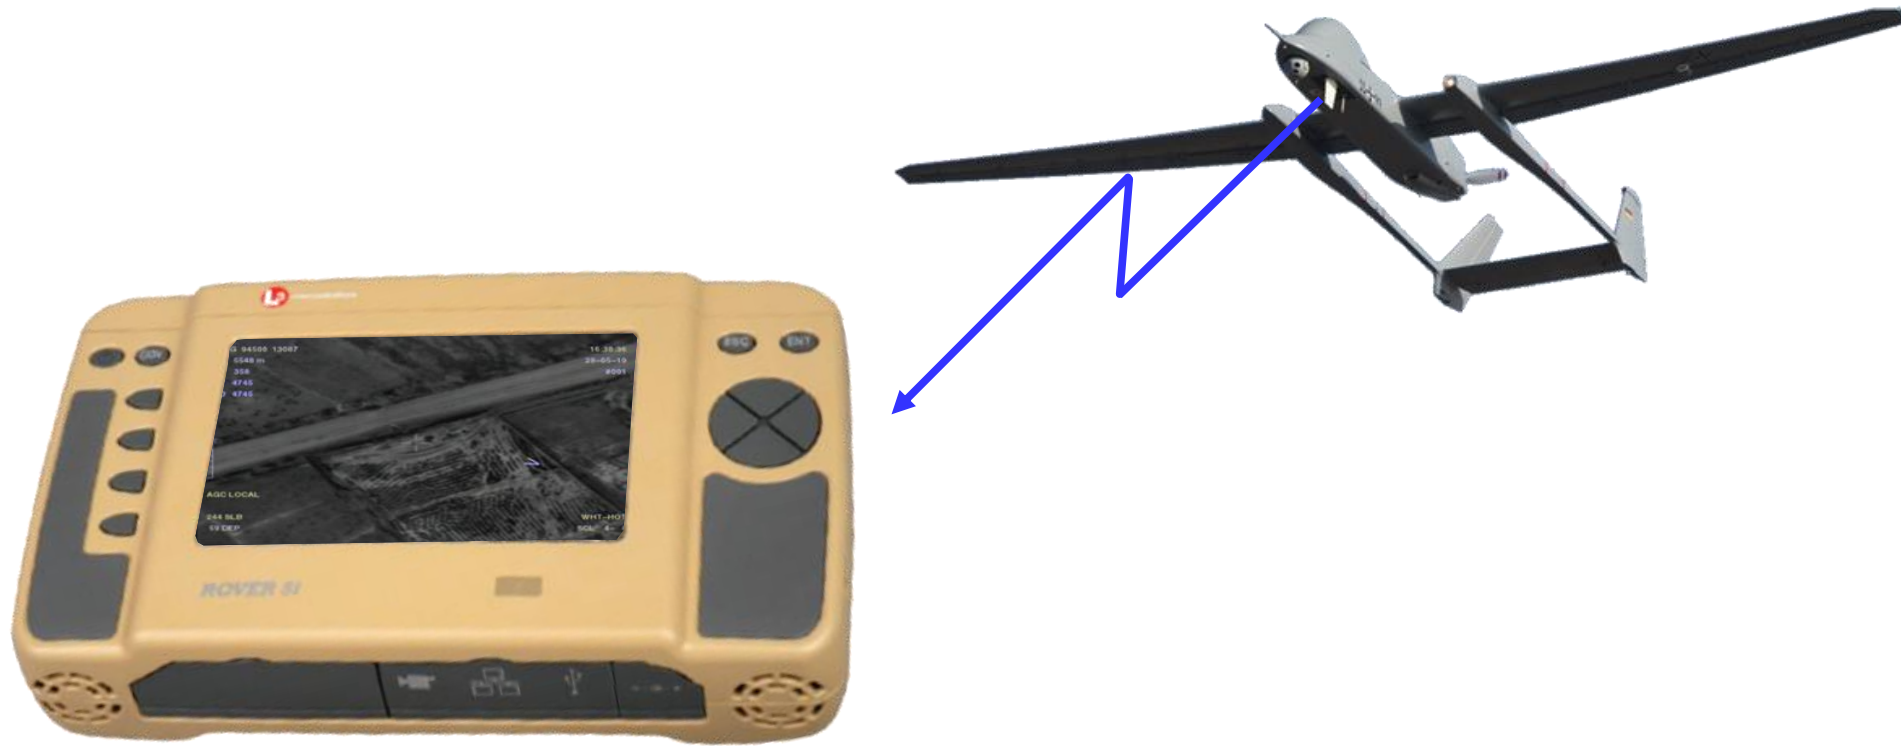
Remote Video Terminal (RVT) / ROVER
