## Developments in Norwegian Offshore Helicopter Safety

Knut Lande

Former Project Pilot and Chief Technical Pilot in Helikopter Service AS

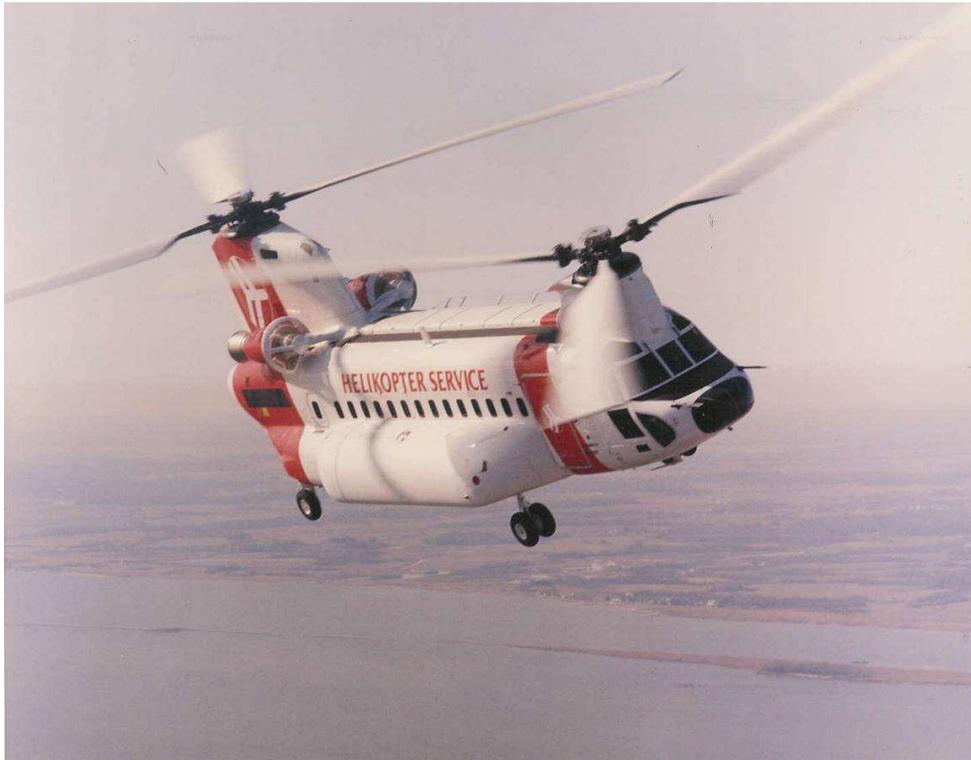
*The ideal Ekofisk Helibus Boeing Helicopters BV234LR Chinook.*

The BV234LR was a very successful offshore helicopter on the Ekofisk route structure. In 1995 Helikopter Service lost the contract to the newly formed Norsk Helikopter and AS332L1 Super Puma and the three helicopters were sold to Columbian Helicopters in USA. The loss of the Chinook contract was caused by NCAA issuing a dispensation from Norwegian offshore regulation which mandated use of onshore based alternate landing site without informing Helikopter Service of this possibility. That was clearly a favoring and rewarding of one operator and against the generally accepted safety norm in Norwegian offshore operations. This was the only time the concept of using offshore based alternate landing site was used in Norway, and in later contracts the oil companies required the bidders to specify onshore alternate. Today this is stated in Norwegian Oil and Gas' recommended Guidelines 066 for offshore helicopter transport. This is one example of how the NCAA contributed negatively to the Norwegian offshore helicopter safety instead of promoting safety. This was an indication of lack of knowledge of offshore helicopter operations among the NCAA personnel. The same can be said of the contract personnel in the oil company where the focus was on minimum cost.

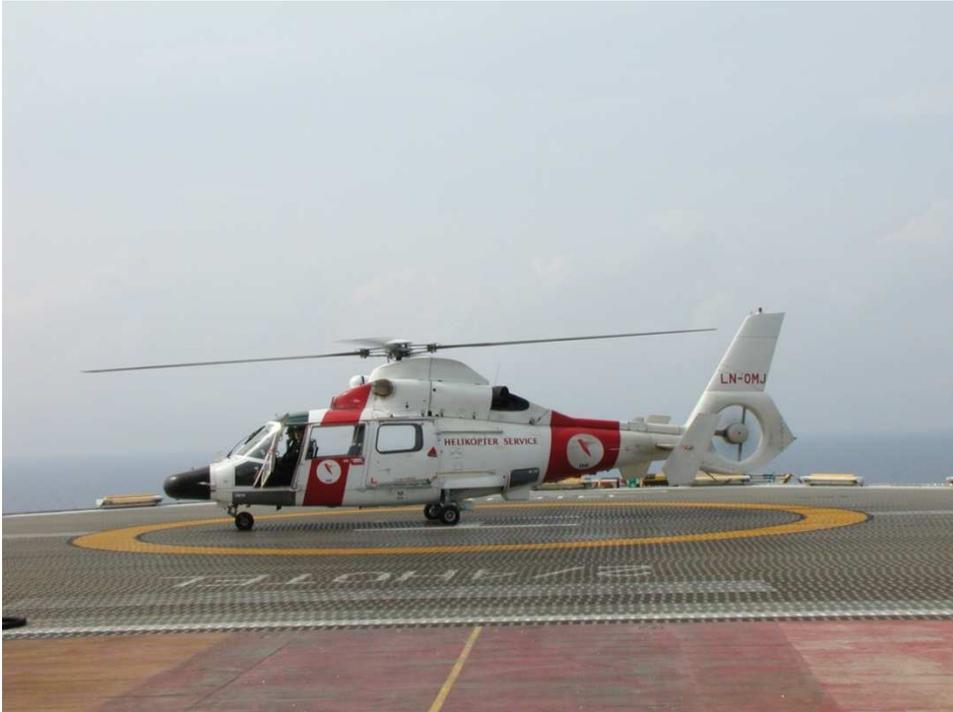
*Eurocopter AS365N2 replaced the Bell 212 as shuttle/SAR helicopter at Ekofisk in 1995.*

Helikopter Service kept updating its helicopter fleet by introducing Bell 214ST offshore based shuttle helicopter, and new transport helicopters like AS332L1 and L2. The Bell 212 shuttle helicopters were updated with SAR equipment and eventually replaced by AS365N2 shuttle helicopters with SAR equipment.

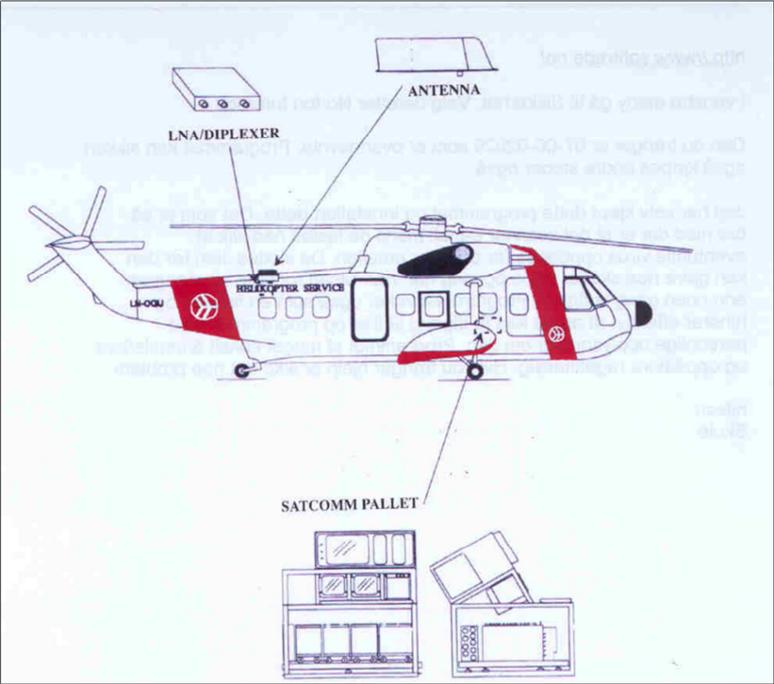
The S-61N ADS-C test installation.

Helikopter Service made available an S-61N helicopter, installed test equipment and flew several test flights. The test results were promising and NCAA (LV Directorate/Technical

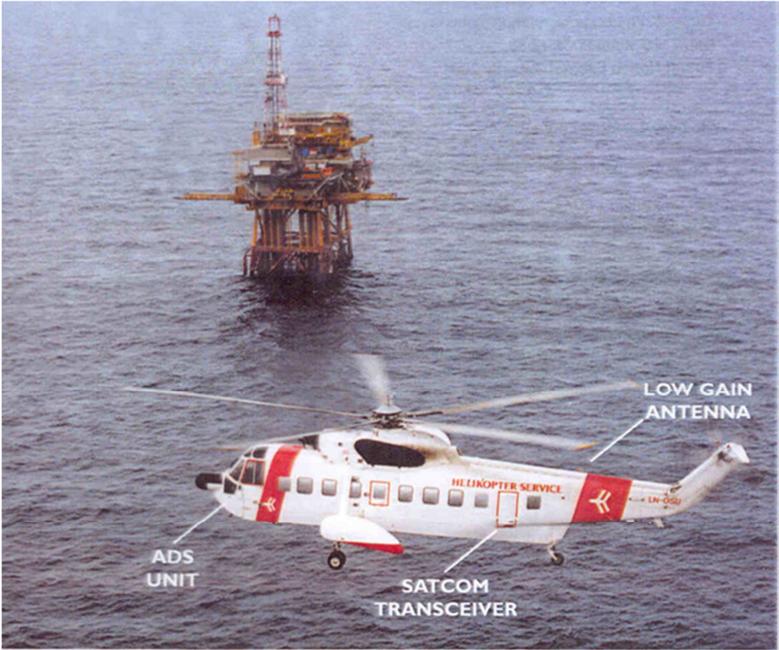
The S-61N test aircraft.

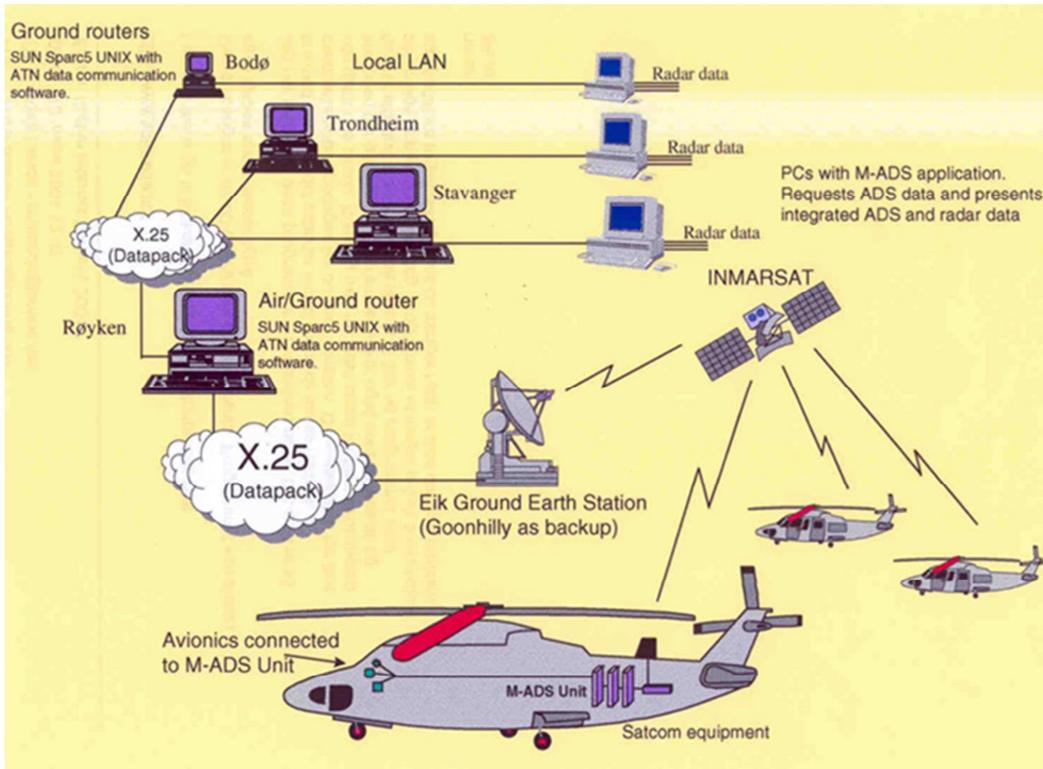
*The Norwegian M-ADS-C Satellite Surveillance System.*

The M-ADS system was tested during a trial period and became eventually mandated by NCAA. The system allowed direct routing outside radar coverage and allowed ATC radar operators to have the GPS position of the helicopters indicated on their combined radar/ADS screens all the way to landing offshore, or in case of accident, to the last indicated position on the sea surface. The system was a great advancement to overall helicopter passengers' safety. The safety potential was indicated during the search for LN-OPG at Norne.

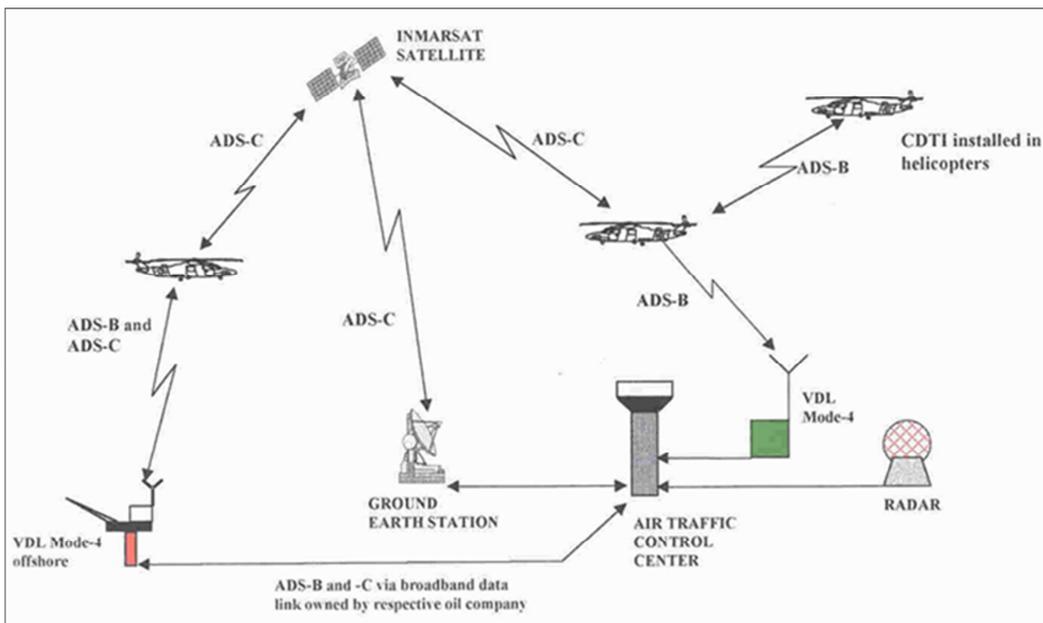
*The proposed Norwegian Dual Link ADS-C and ADS-B System.*

The project plan had an option to extend the M-ADS (ADS-C, Contract) to include ADS-B (Broadcast), but this option was never activated due to lack of funding. If it had been developed at the time (during the late 1990-ies) Norway could have had an operational offshore ADS-B surveillance system (Dual Link ADS) from around 2000. This is an indication of short sighted future planning.

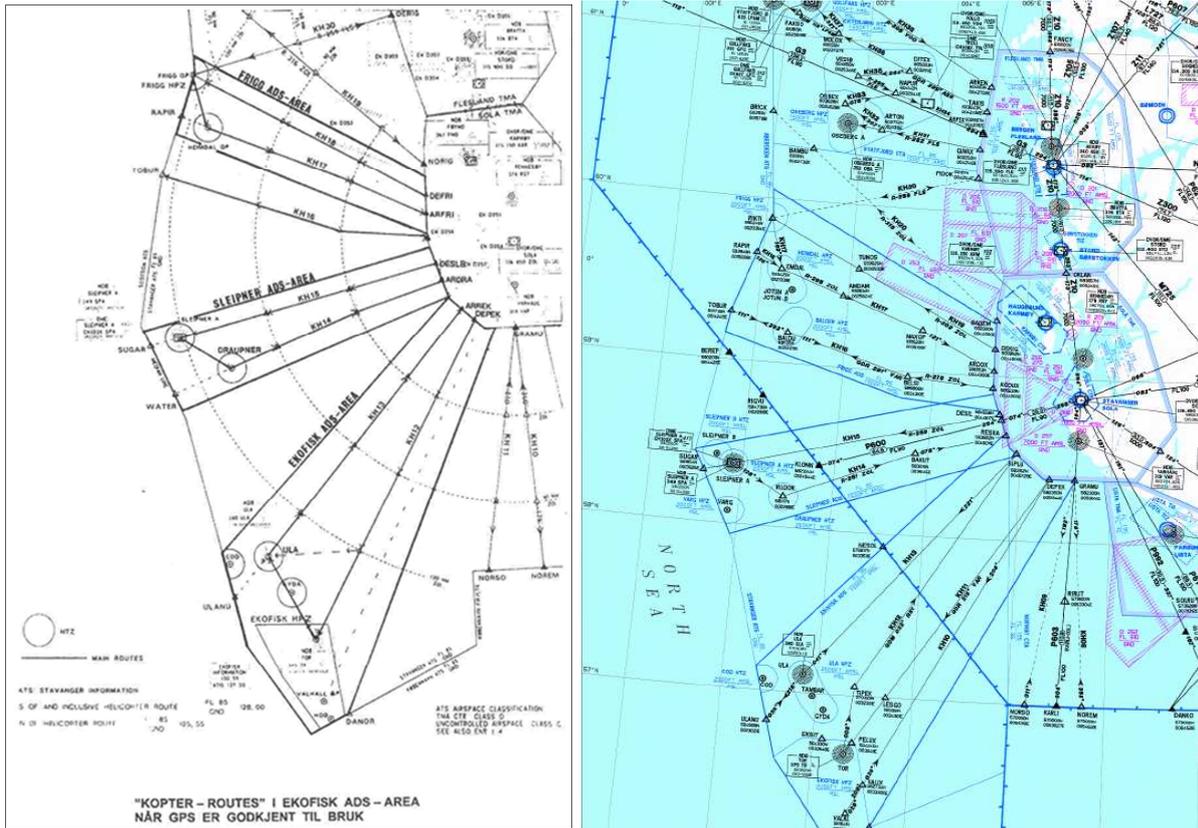
The designated ADS areas over Norwegian North Sea.

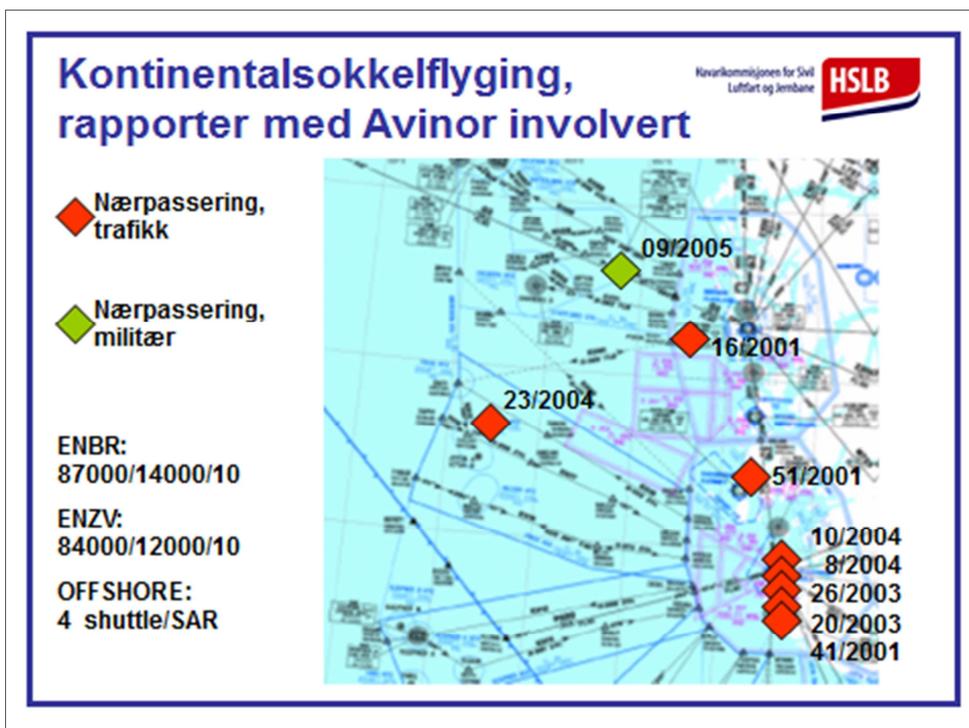
Offshore ASR reports to AIBN involving Avinor ATC.

A confirmation of the HSS 1 risk estimation regarding ATC is indicated by the figure from AIBN of 2005. It shows air traffic incident reports involving offshore helicopters.

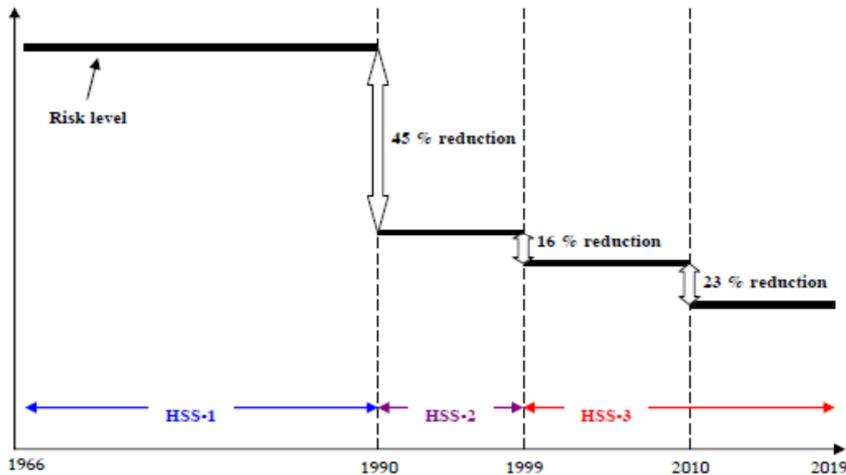
Figure 0.1 shows the risk reduction in the three 10-year periods that have been analysed. In HSS-2 the risk reduction between the two first periods was estimated to be 45 %. In HSS-3 a risk reduction of 16 % is estimated for the period 1999–2009 compared to the previous period (1990–1998), and an additional 23 % risk reduction is predicted for the coming 10 year period: 2010–2019. The reduction of 23 % in this period is given under the assumption that already planned improvements will be implemented, ref. above list. In addition, a further reduction of risk is expected if additional safety measures are implemented, see below.

Figure 0.1. Estimated change in risk levels 1966–2019.

HSS 3 corrected somewhat the risk reduction figures from HSS 2. The estimated risk reduction from 1966 to 1990 was 45 % (from 50 %), the risk reduction in the period 1990 to 1999 was estimated to be 16 % (from 12 %) and the risk reduction between 1999 and 2010 was estimated to be 23 %.
